## **Typhoon Maemi and Impacts on Lower Nakdong River, South Korea**

**Abstract.** In South Korea, the average annual frequency of typhoons over 30 years, from 1971 to 2000, is 26.7 per year. Among the annual typhoons, Typhoon Maemi of September 12, 2003 was the worst typhoon to hit South Korea for more than a decade, causing wide damage from the Nakdong Rver basin to the port of Pusan and the populated areas in the southeast of the peninsula. More than 110 people were killed in Korea. Several bridges collapsed and about 18,000 buildings were either destroyed or damaged by the typhoon. The characteristics of Typhoon Maemi, on the Nakdong River basin, and flood damages are analyzed using the satellite data and field measurements of hydrologic and hydraulic conditions.

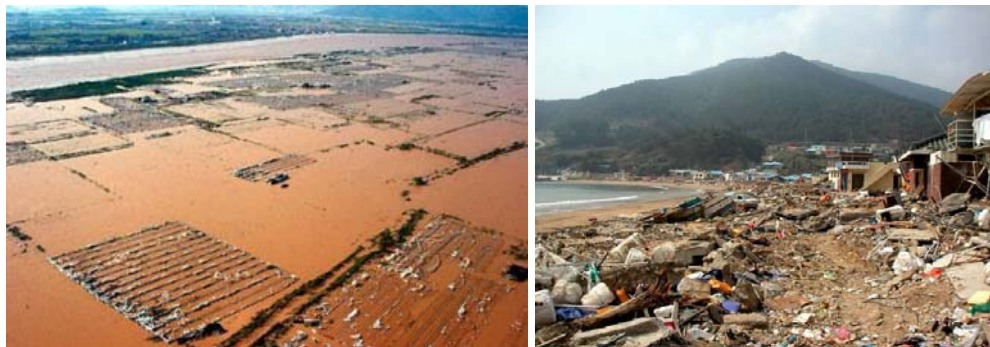
**Figure 7.** Flood damages of Pusan of left, [AP] and Wah Yeon Beach on Geoje Island of right, [photo by Paul J. Riley]

In Figure 7, the left is the aerial view which shows a flooded rice field area after Typhoon Maemi hit Pusan on Saturday, Sept. 13, 2003 and the right shows the flood damages of Wah Yeon Beach on Geoje Island taken on Sept. 15. Figure 8 shows another damage that the ferry-shaped hotel is toppled over sideways after Typhoon Maemi hit Pusan Port, Pusan, Saturday, Sept. 13, 2003.

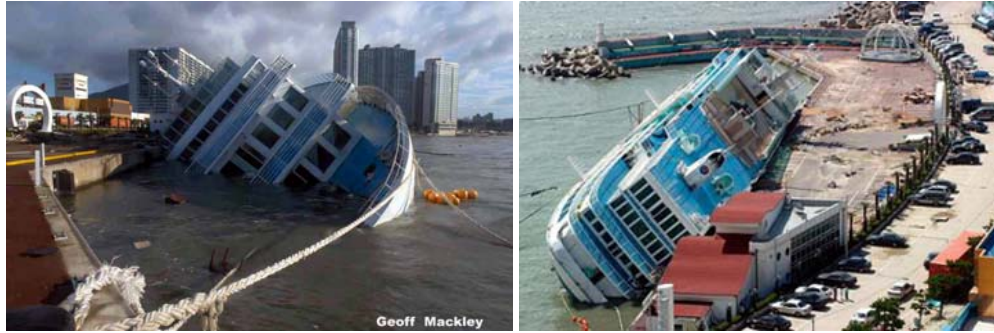
**Figure 8.** Damages of ferry-shaped hotel after Typhoon Maemi hit Pusan Port [AP]

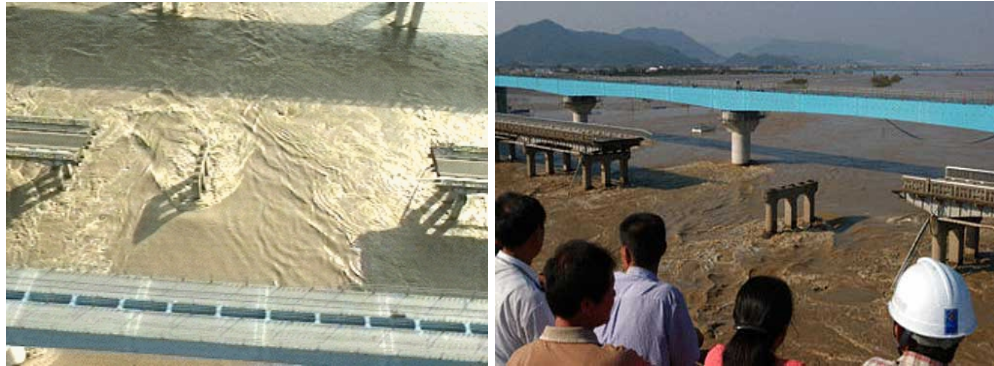
One of the typical damage is the bridge collapse and it is shown in Figure 9. At this time, September 14, the 1.06 km-long Gupo bridge partially collapsed with the loss of 19<sup>th</sup> pier. It was due to high velocities in the river and bridge scour around the piers. The discharge of the Nakdong River peaked on September 14 at a value around 13,000 cubic meters per second.

**Figure 9.** Gupo bridge failure after Typhoon Maemi [Yonhap]

The Typhoon Maemi caused extensive damage including a bridge failure on the Nakdong River of South Korea. The data and information examined include satellite maps, rainfall intensity patterns, wind speed, etc. Typhoon Maemi caused extensive damage over the large area with extremely flash hydrograph of over 400mm of local precipitation and a severe storm surge. The water level recorded at Gupo bridge in Lower Nakdong River reached maximum 5.06m on September 12, and the discharge of the Nakdong River peaked on September 14 at a value around 13,000 cubic meters per second. Around 18,000 buildings were either destroyed or damaged by the strong winds and more than 110 people were killed in Korea. Gupo bridge on the Lower Nakdong River partially collapsed with the loss of 19<sup>th</sup> pier due to high velocities in the river and bridge pier scour. It is important ensure flood

conveyance capability during floods and limit possible bed elevation changes. These conditions affect the stability of the bridges located near the Nakdong River Estuary Barrage.
