Use Of A Rock Ramp For Grade Control – Dueñas Bridge Case

Julio M. Kuroiwa, Alfredo J. Mansen and Edgar Rodriguez
Mansen, Kuroiwa Ings Asoc. SAC

Abstract. In October 2001, an inspector from Inversiones Metropolitanas (INVERMET – a Lima city agency) discovered that significant scour had occurred underneath the right abutment of Dueñas Bridge. The bridge designers as well as a team of experts was invited to solve the problem. The authors accepted the invitation to participate in the solution. During the course of the investigation, it was evident that the river morphology had changed dramatically since the construction of the bridge. A rock ramp was proposed to stabilize the stream at the Dueñas bridge. This structure has been in service for three years now. This paper deals with the findings of the authors with respect to the evolution of the river morphology and the temporary solution that was adopted for protecting the bridge's foundation.

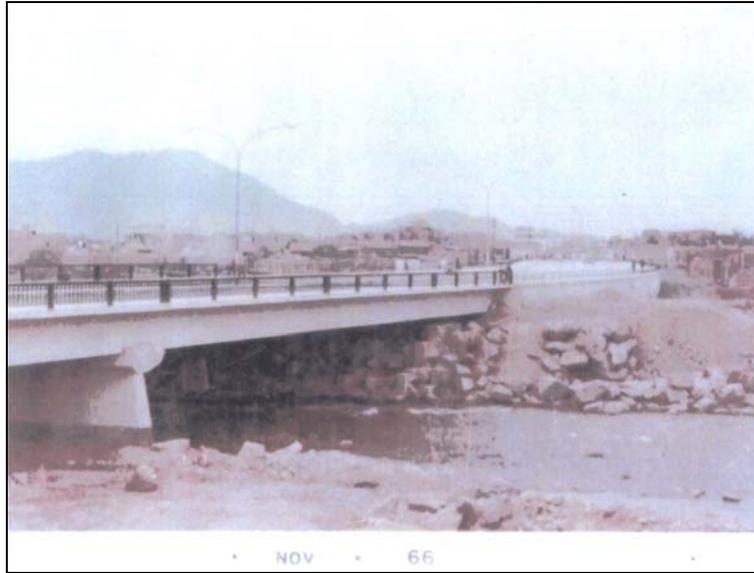
Figure 1. View of the Dueñas Bridge in 1966. This photograph was taken from the left bank. Notice that river flows underneath the two openings of the bridge.

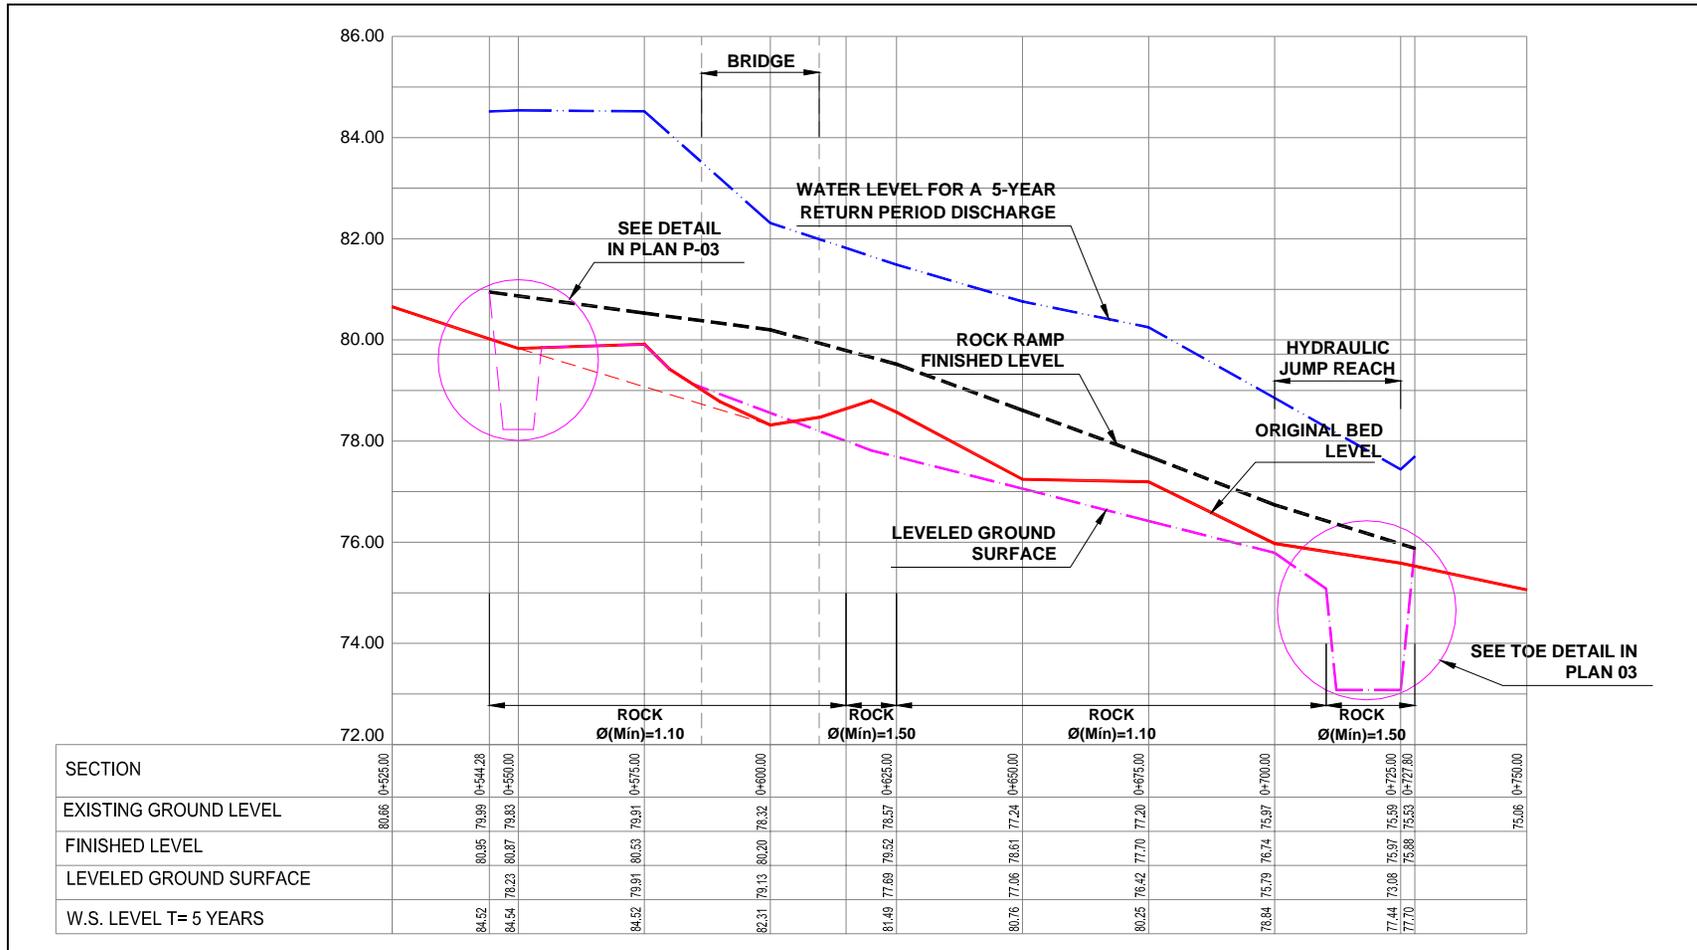
Figure 6. Profile of the rock ramp at the Dueñas Bridge.

The river bed, as well as the banks needed to be protected against scour. Because the river bed cannot be lowered to place the erosion protection layers, the final rock level of the ramp will be accommodated approximately following the leveled ground (see figure at the end of the paper). A gradual change in slope is allowed from approximately 50 m (164 ft) upstream so that the critical cross section is covered with a layer 1.5 – 2 the calculated typical rock size. To compensate this change in level, the second portion of the ramp is made steeper.

The rock ramp is divided in two reaches. From section 0 + 550 to 0 + 620 it has a 1.33 % slope. From the latter section to 0 + 725 it has a 3.65 % slope until it intercepts the natural terrain. (See Figure 6 at the end of paper). The profiles of the backwater curves corresponding to the two-year flow discharge ($129 \text{ m}^3\text{s}^{-1}$) and five-year flow discharge ($198 \text{ m}^3\text{s}^{-1}$) are shown in Figure 4. This output was obtained using USACOE’s HEC-RAS 2.2b.
