## **Typhoon Maemi and Impacts on Lower Nakdong River, South Korea**

**Abstract.** In South Korea, the average annual frequency of typhoons over 30 years, from 1971 to 2000, is 26.7 per year. Among the annual typhoons, Typhoon Maemi of September 12, 2003 was the worst typhoon to hit South Korea for more than a decade, causing wide damage from the Nakdong Rver basin to the port of Pusan and the populated areas in the southeast of the peninsula. More than 110 people were killed in Korea. Several bridges collapsed and about 18,000 buildings were either destroyed or damaged by the typhoon. The characteristics of Typhoon Maemi, on the Nakdong River basin, and flood damages are analyzed using the satellite data and field measurements of hydrologic and hydraulic conditions.

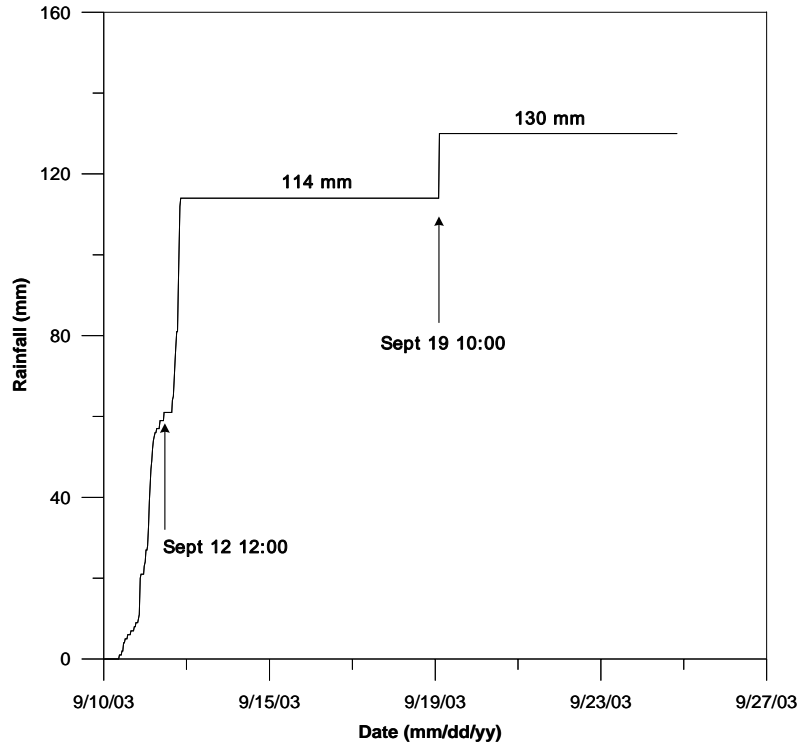
**Figure 5.** Mass rainfall curve at Yangsan gauging station (Source: Korea Water Resources Corporation, KOWACO)

prevent a large flood due to high tides. The channel of Nakdong River was designed to convey a design flood of 18,300 cubic meters per second. Figure 5 show the mass rainfall curve at the Yangsan station and Figure 6 is the water level hydrograph during the passage of Typhoon Maemi with discharge data. During Typhoon Maemi, the water level significantly exceeded normal levels due to the strong westerly winds. The water level recorded at Gupo bridge reached maximum 5.06m on September 12, and the discharge of the Nakdong River peaked on September 14 at a value around 13,000 cubic meters per second. That is, the flood level exceeded the warning stage of 4m and the stage of 5 m corresponds to 70% of the project flood for the Nakdong River.

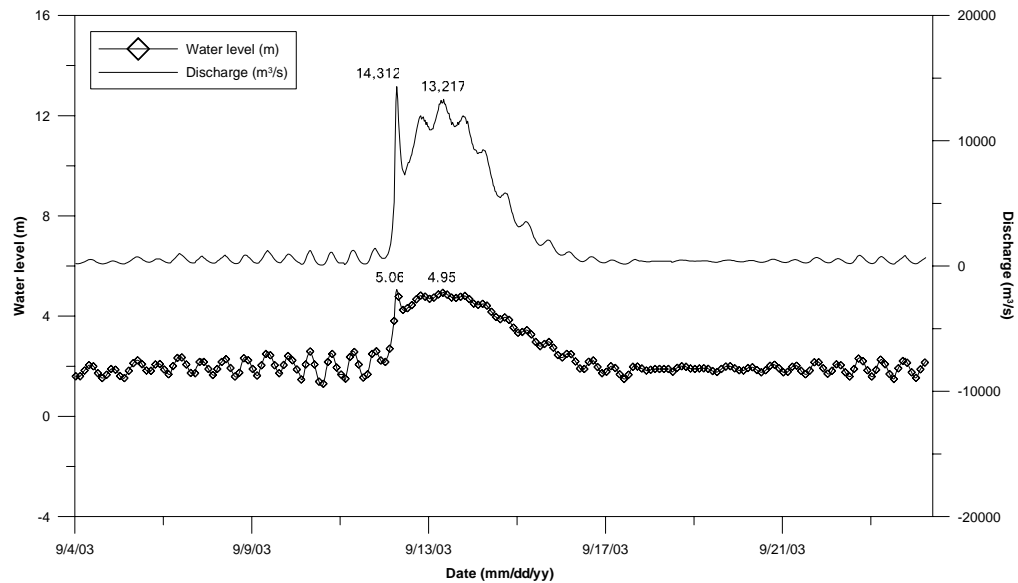
**Figure 6.** A water stage and discharge graph at Gupo bridge (Source: KOWAKO)
