Appraising Surface Water Quantity and Quality in the Upper Arkansas River Basin in Chaffee County, Colorado

G. H. Steed¹, T. K. Gates, J. D. Niemann and J. W. Labadie
Department of Civil and Environmental Engineering, Colorado State University

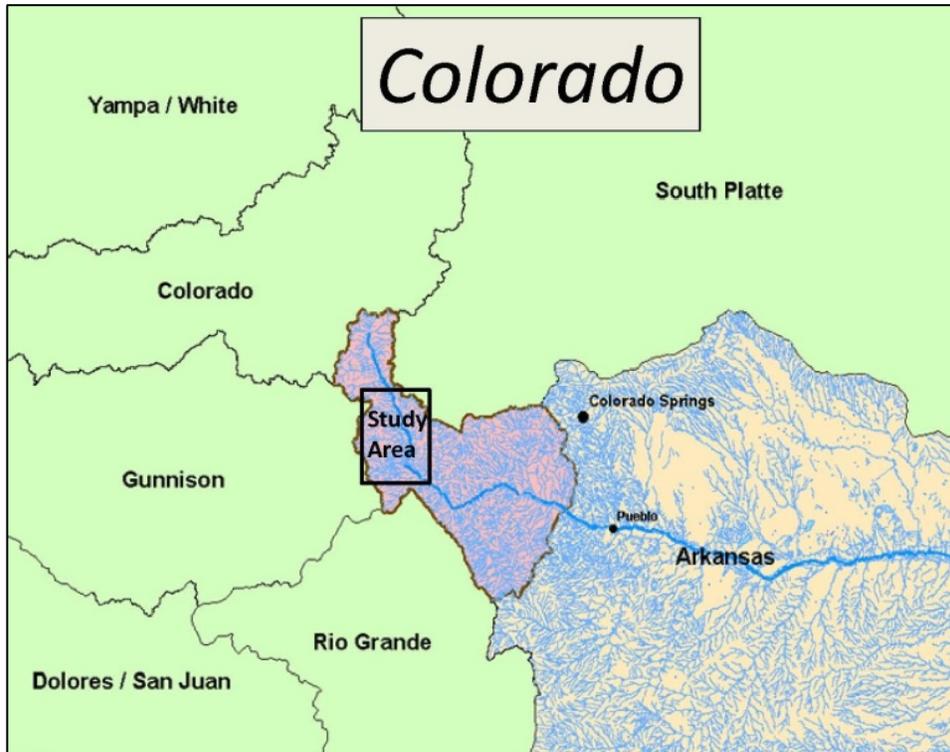
Figure 1. River Basins of Colorado showing the study area in central Colorado in the upper headwaters of the Arkansas River Basin.

In the Arkansas River Basin, the largest drainage basin in the state (Figure 1), projections show a 55% population increase from 2000 to 2030, producing a 38% increase in gross water demand (CWCB 2004). In the portion of the basin above Pueblo Reservoir, known as the Upper Arkansas River Basin (UARB), the population is projected to increase by 72% within that same time period, resulting in a 60% increase in gross water demand (CWCB 2004).

The study area (Figure 1) lies in Chaffee County and extends from the town of Granite in the north to Salida in the south. The valley floor of the Arkansas River is a relatively flat, deposit-filled inter-montane valley (Figure 2). It is the second northernmost structural basin of the Rio Grande Rift (Chapin and Cather, 1994). Tectonic rifting formed a deep structural basin bounded by normal faults, which has filled with alluvial, glacial, and other basin-fill deposits to a depth of about 5,000 ft (Watts 2005). On the west side of this valley is the Sawatch Range, which contains a large number of 14,000-foot mountain peaks and collects considerable snowpack during the winter. The Sawatch Range feeds four major, perennial tributaries to the Arkansas River within Chaffee County. On the east side of the valley is the Mosquito Range, which has 2 peaks over 13,000 feet in Chaffee County (most of the range crests near 10,000 ft) and receives much lower precipitation. The Mosquito Range feeds one small perennial stream north of Buena Vista, called Fourmile Creek. Precipitation is highly variable within the study region, ranging from about 10 in/yr on the valley floor to as much as 40 in/yr in the surrounding mountains, particularly the Sawatch Range (Crouch et al 1984).

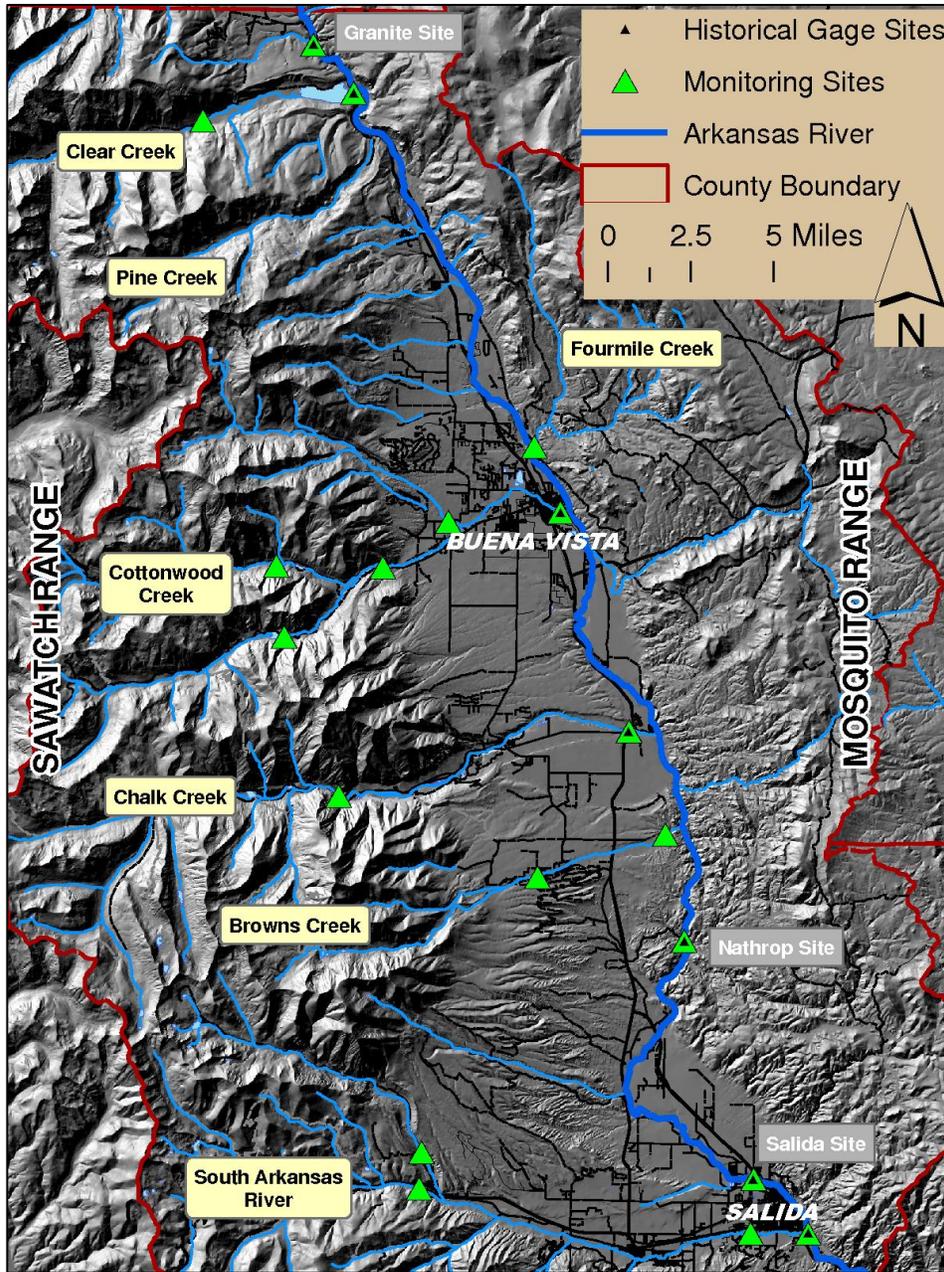
Figure 2. Study area and water monitoring network.

Data collection sites were selected to observe both the main stem of the Arkansas River and its largest tributaries in Chaffee County (Figure 2). Routinely monitored tributaries include Clear Creek, Fourmile Creek, Cottonwood Creek, Chalk Creek, Browns Creek, and the South Arkansas River. In most cases, upstream and downstream sites were identified. To the extent possible, the upstream sites are located upstream of the points where the tributaries enter the Arkansas River valley and upstream of any diversions. If the tributary forks into several branches within the valley, multiple upstream sites were monitored. In the end, the data at the upstream sites are intended to characterize the flows before they are modified by interactions with the groundwater or interventions by humans. The downstream points are located very close to each tributary's junction with the Arkansas River, so these observations characterize the flows as they enter the main stem. Three sites were used to monitor the main stem of the Arkansas River. One point is located where the river enters the study region, one point is located at an intermediate point, and one point is located near where the river leaves the study region.

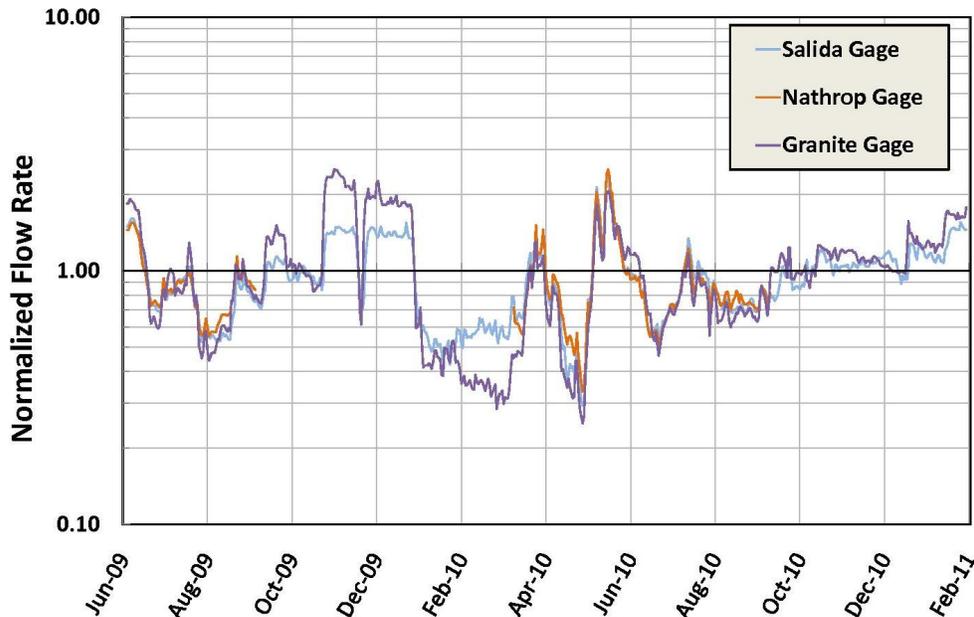
Figure 3. Daily mean flow rate at three Arkansas River gages during the study period normalized by the long-term average of the daily mean flow rate for the same day.

Figure 3 shows the daily average flow rate at the three gaging stations along the Arkansas River during the study period (June 2009 – February 2011) normalized by the

long-term average flow rates on the same date. The long-term average was calculated using the preceding 20 to 25 years, depending on the available gage records. The plot shows a noteworthy consistency across all three sites for the flow patterns during the study period. The averages of the normalized flow rates during the study period for the Granite, Nathrop, and Salida sites are 1.01, 0.88, and 0.94, respectively. These values suggest that, during the study period as a whole, the flows at these sites were close to or slightly below the long-term average conditions.

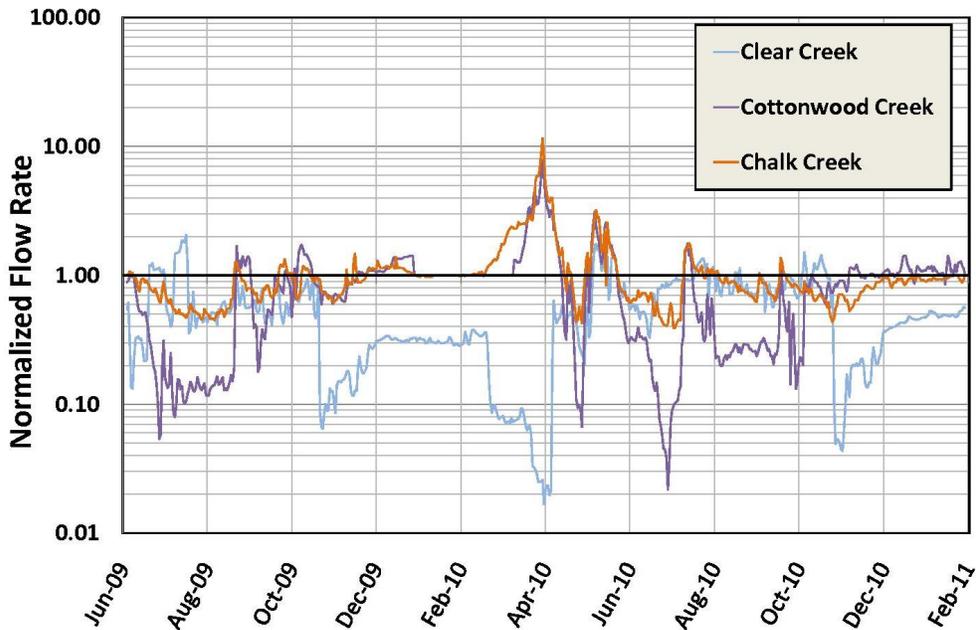
Figure 4. Daily mean flow rate at three tributary gages during the study period normalized by the long-term average of the daily mean flow rate for the same day.

Figure 4 shows a similar plot for three tributary gages near their confluences with the Arkansas River. The site at the South Arkansas River confluence was taken out of service during the period of monitoring due to long-term impairment and thus was not utilized for long-term data analysis. The Clear Creek gage is just downstream of Clear Creek Reservoir and measures controlled releases based upon reservoir operational rules. Abrupt jumps on November 15 and April 15 in the Clear Creek plot suggest recurring adjustments in the reservoir releases on those dates. The averages of the normalized flow rates during the study period for Clear Creek, Cottonwood Creek, and Chalk Creek are 0.55, 0.87, and 1.07, respectively. The low value for Clear Creek suggests that Clear Creek Reservoir was generally in a period of net storage gain during the study period rather than more typical flow releases. Cottonwood Creek and Chalk Creek appear to have near normal flows with the exception of a notable spike during the 2010 snowpack runoff. Greater relative variability in the Cottonwood Creek plot could be a reflection of anthropogenic influences. Cottonwood Creek runs through the town of Buena Vista, has multiple upstream reservoirs, and, according to the records of Water District 11 found at the Chaffee County Courthouse, is subjected to 63 adjudicated water rights totaling over 213 cfs. For comparison, Chalk Creek has only 29 adjudicated rights totaling 150 cfs.

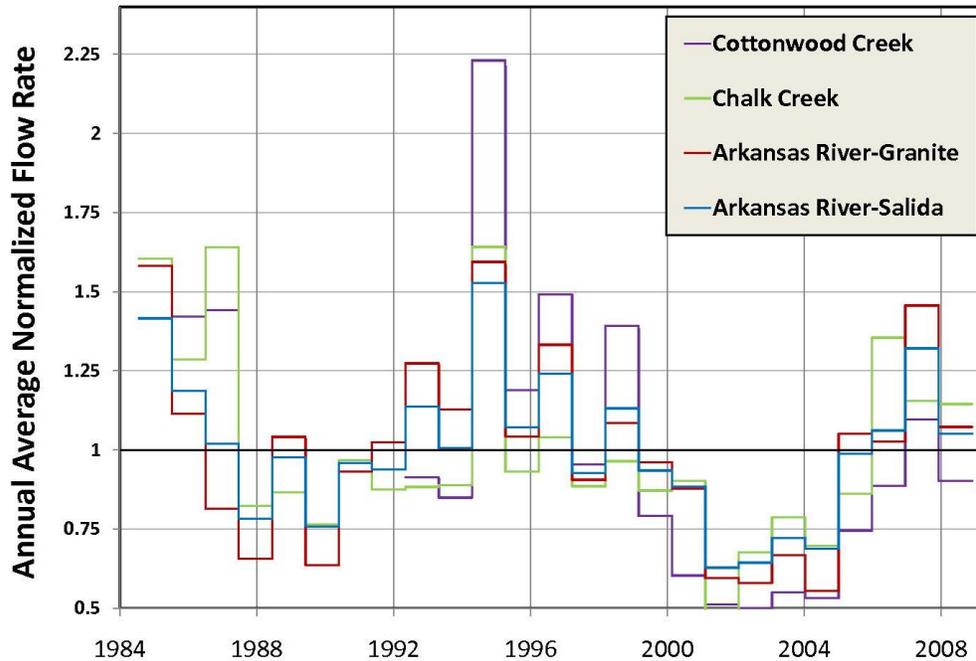
Figure 5. Water year (Oct 1 – Sept 30) average of normalized daily mean flow rates at selected gages over the period 1984 through 2009.

Figure 5 examines whether longer-term trends are observed in the discharge at the gage locations. To create this plot, the average value of the normalized flow rate is calculated for each water year (October 1 – September 30) from 1983 to 2008. In this plot, a year for which every daily value matches the long-term average daily value would have a value of 1 for that year. The Nathrop and Clear Creek gages are not shown because of seasonal-only operation and highly controlled reservoir release flows, respectively. The four gages plotted show consistency over the time period analyzed. Cottonwood Creek’s variation from average is larger than the other gages, with higher peaks and lower valleys in the plot (note that data are unavailable for this gage from 1988 to 1992). However, the relatively short time period and high overall variability prohibit any definitive conclusions. Further analysis over a longer time period with particular attention to Cottonwood Creek is warranted before any conclusion is reached.
